## SCUBA - FIX TECHNICAL RELEASE 1.0 : BLADDER REPAIRS

This document provides the approved guidelines to carrying out bladder repairs with Scuba-Fix repair valves, under controlled environment. It serves primarily to show the difference in post-repair results should the pre-repair process are prepared differently.

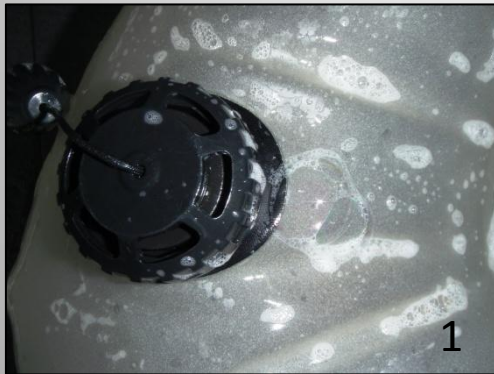
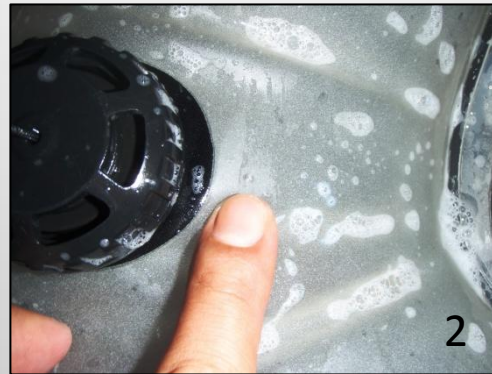
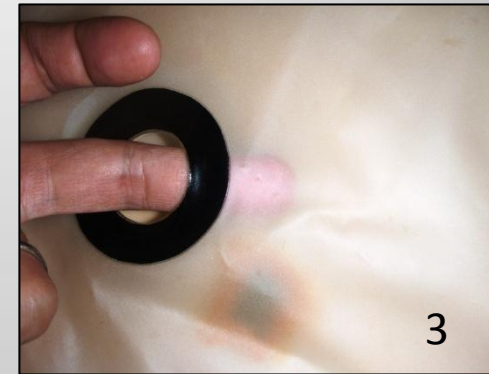
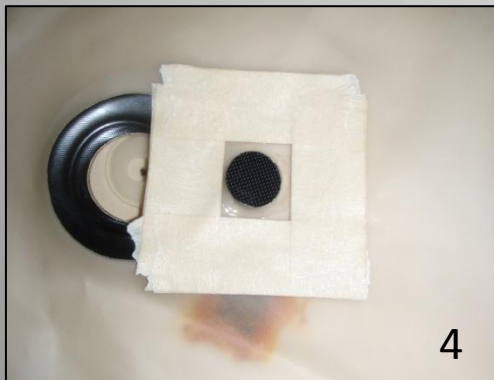
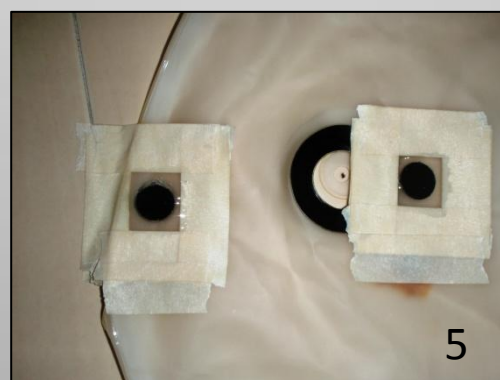
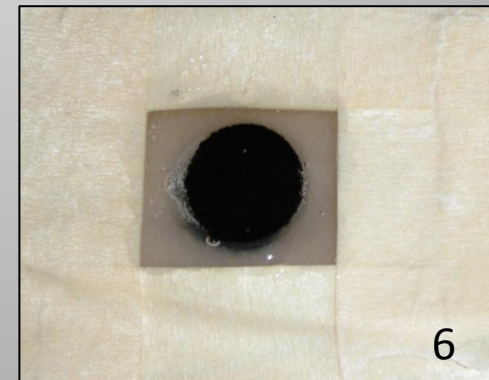
An OMS Bladder was found to have multiple punctured holes. We identified the holes via a snoop test method. The holes were immediately patched with our adhesive and a BCD patch fabric.

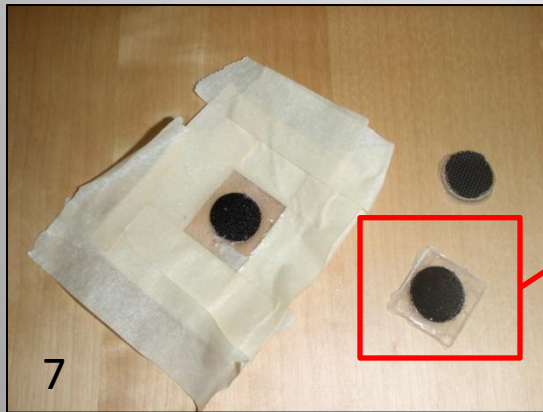
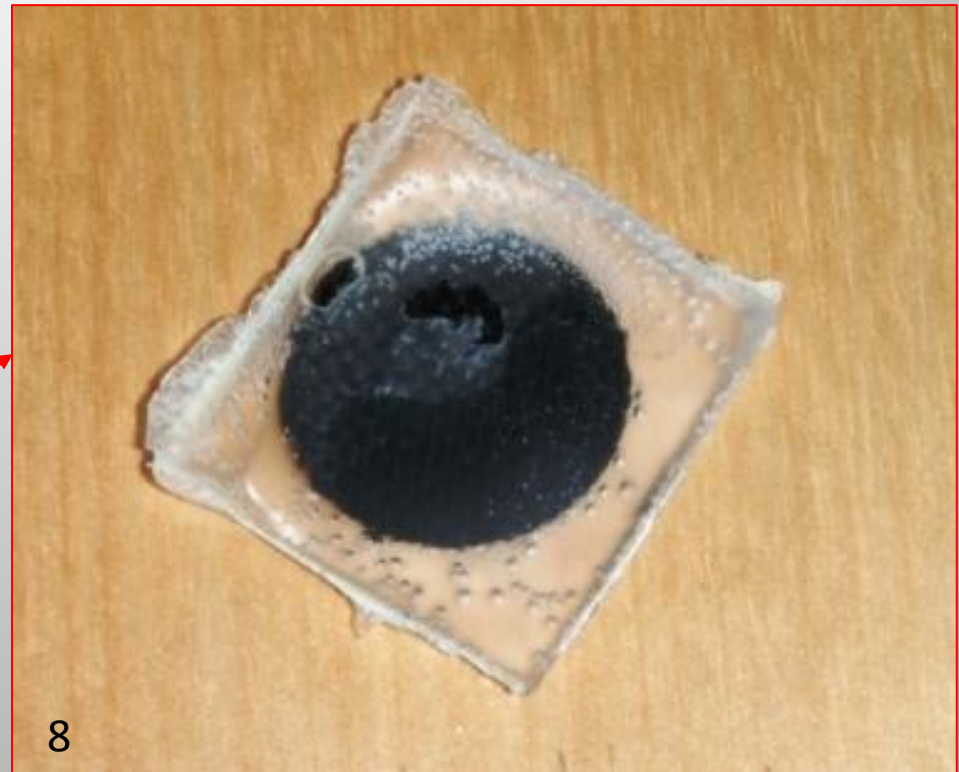
The end result was an unsuccessful bonding of the adhesive to the smooth surface of the bladder. The patch peel off effortlessly with little removal effort, displaying no bonding taking place between the bladder surface and our adhesive.

The solution to the problem is resolved by increasing the Ra (Surface Roughness Value). This is achieved by sanding down the affected area with a sand paper and when the adhesive is introduced, ensure it doesn't overflow the sand down area.

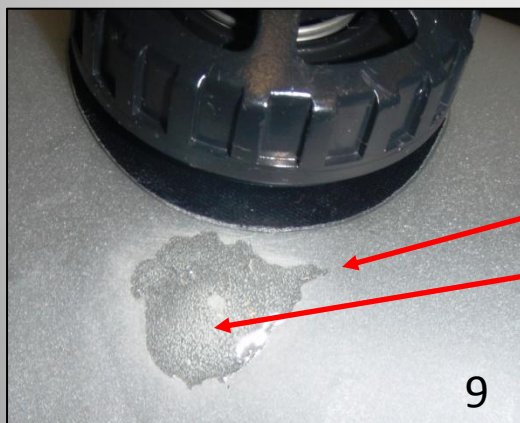
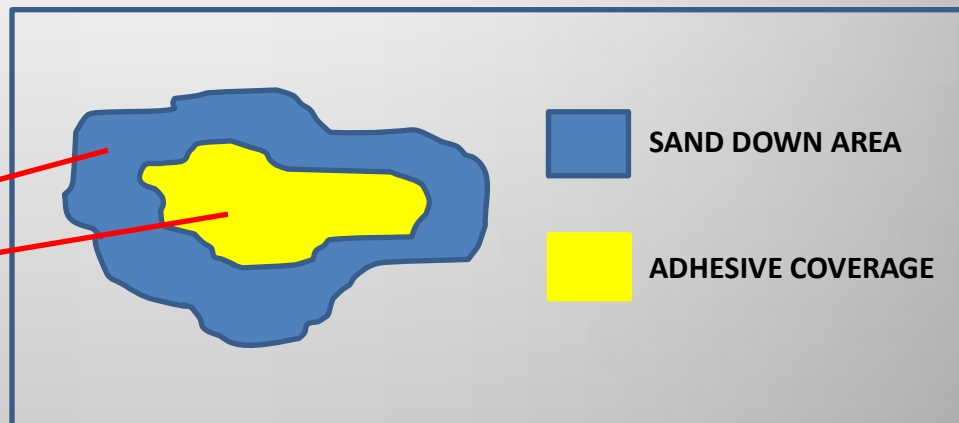
So effective was the bond, we didn't need an extra patch on the bladder.

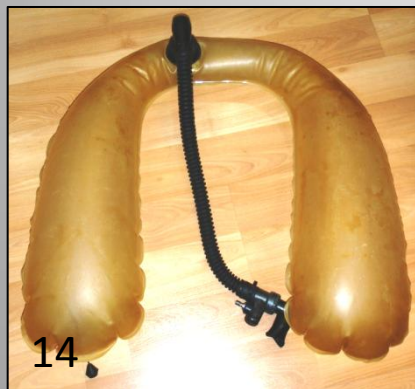
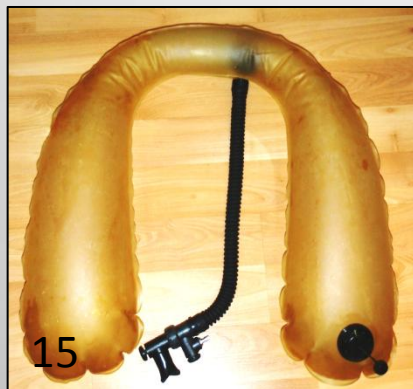
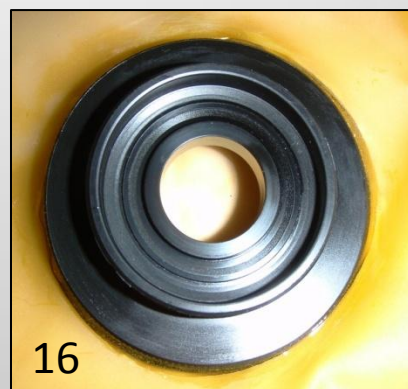
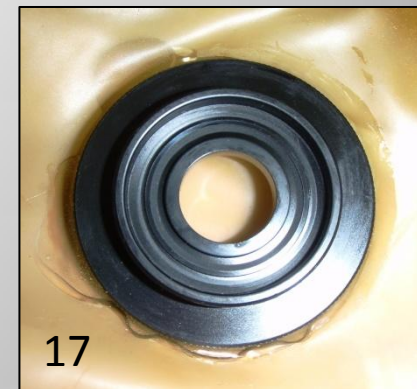
Repaired BCD was a Zeagle – Ranger. The bladder surface displayed the same smoothness as the rest of the technical BCDs brands i.e. OMS, Halcyon, Zeagle, BOSS...etc.

**If the pre-repair preparation is poorly carried out, the repair will not last.** Due to the fact our valves are circular in shape, it will hold the position longer than a regular puncture patch but the consistent inflating and deflating action will stretch the BCD material and cause material and adhesive separation around the bonding areas.
